Landslides on river banks in the western part of Podhale (Central Carpathians, Poland)

Kukulak, J., Augustowski, K., 2016. Landslides on river banks in the western part of Podhale (Central Carpathians, Poland). *Geological Quarterly*, **60** (3): 561–571, doi: 10.7306/gq.1273

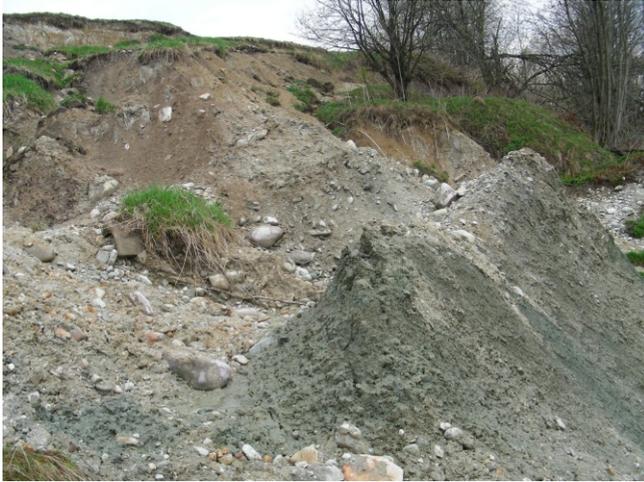
Fig. 4. Compressional fold in clays in the landslide at Chochołów

The relief of the landslide varies also along its length. Numerous sheets of clay with turf are present in the upper part (Fig. 3). One of them has preserved its continuity along the width of the landslide, and lies on the inclined surface. The other sheets are detached from the crown along fractures and slid down over a distance dependent on the slope angle: the steeper the slope, the longer the distance of translation. There are also small secondary crowns 1–1.5 m high. The arcuate crown of the landslide is incised and recessed by 1–1.5 m at the outlets of the ploughing rills. Erosional rills are cut in the landslide surface below these outlets. Cones of washed-out gravels lie within these rills. A distinctive feature of the lower part of this landslide is debris ridges with clay cores coated with gravel. Some ridges are entirely built of clay (Fig. 4) and have a form of

a series of imbricated folds. This part of the landslide is boggy and the clays are soft and plastic. The landslide is wet up to the boundary between the gravels and Neogene claystones. Two groundwater outflows are present along the boundary.

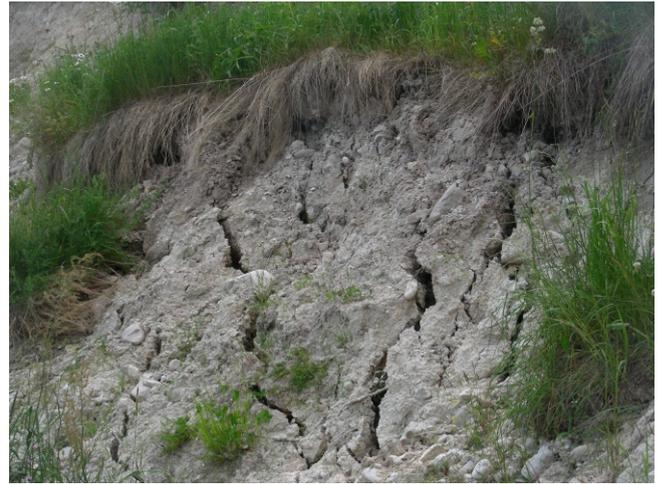
Fig. 5. Fractures and cracks in colluvium of the landslide at Chochołów

The landslide surface is disrupted by sets of cracks diagonal or parallel to the landslide crown or the toe (Fig. 5). Cracks along the toe, where it is being undercut by the river, are oriented 5–55° and parallel to the erosional scarp, which means that they formed by gravity. Cracks on the sandy-gravelly colluvium in the central and upper parts of the landslide, oriented 155–170°, are locally diagonal to the crown.

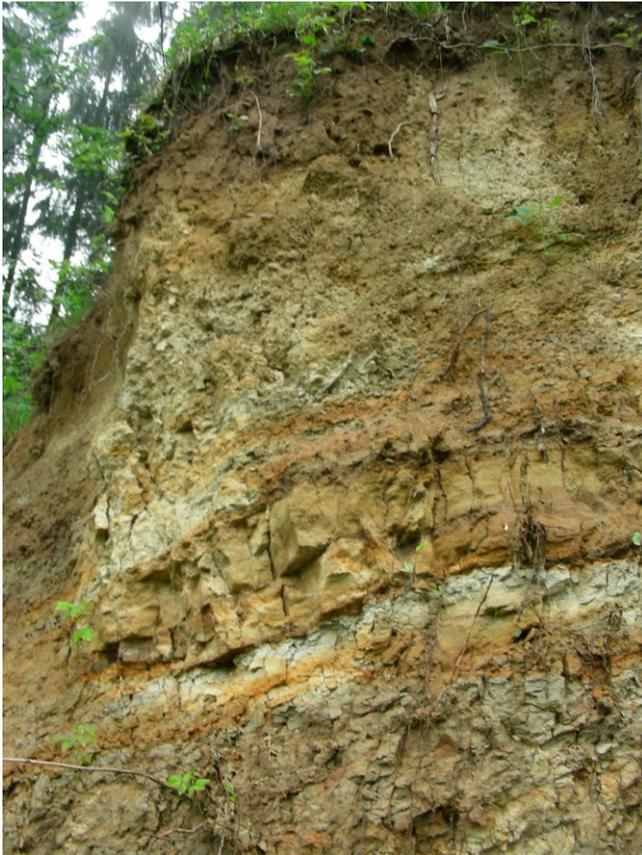
Fig. 7. Bedrock crown of the landslide at Czerwona Góra

whole trough is surrounded by a rocky scarp, much higher on the right, northern side (4–5 m) than on the south (1–3 m; Fig. 7). The crown is arcuate in the highest part of the landslide, but its line is broken with two kinks at the transition to the lateral scarp on the right side. The lateral scarps are straight and parallel to one another.

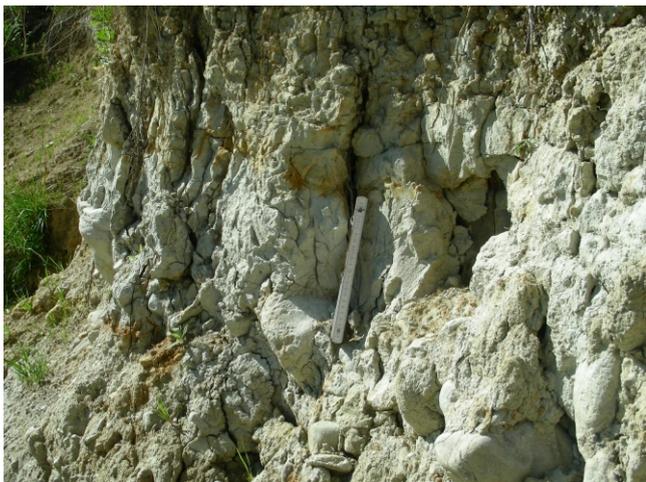
Fig. 9. Fractures and cracks in silts in the upper part of the main scarp of the landslide at Chochołów

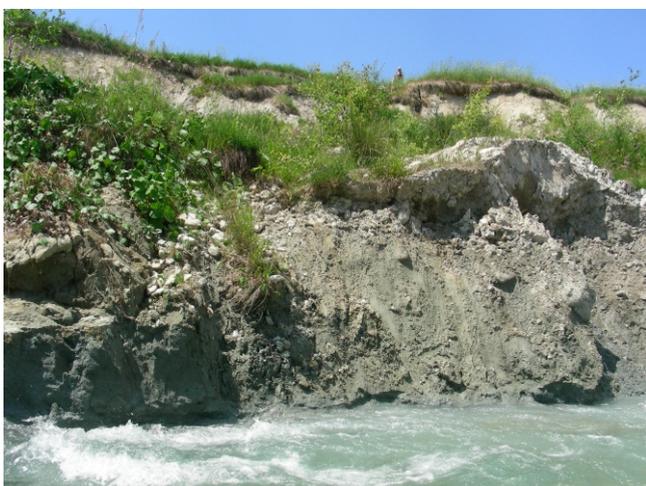
Fig. 10. Neogene claystones eroded by the Czarny Dunajec within the landslide at Chochołów

A classical example of this is provided by the mechanism of the formation and evolution of the Chochółów landslide. The thick topmost low permeability clay retards infiltration of water, hence most of it drains by plough rills to the upper edge of the landslide crown. Near the crown, the joints in the surficial clays are more dense and vertical, facilitating infiltration of water into underlying gravels ([Fig. 9](#)). Poor consolidation of the gravels allows for deep penetration. Increased water content in gravel lowers their shear strength, mainly by reduction of the angle of internal friction ([Schuster, 1979](#)). The gravel becomes still less coherent and slides in layers toward the river. The distance of translation does not exceed the front of the clayey base of the terrace. The slowly wetting Neogene clays swell, and deep slip surfaces do not develop within them. Changes in compressibility and shear strength occur only to the depth of wetting ([Thiel, 1980](#); [Choma-Moryl, 2001](#)). The clays may, however, provide a slip surface for the waterlogged gravels and surficial clays ([Rączkowski and Mrozek, 2002](#)). Only their softened part, adjacent to gravels, is subject to translation. It was ca. 1.2–1.5 m thick in the landslide at Chochółów, up to 2–3.5 m on Czerwona Góra, and 0.5–0.8 m at Ludźmierz. It is in the layer of the most frequent formation of folds under the stresses induced by the weight and movement of the overlying colluvium ([Nescieruk and Rączkowski, 2007](#)). This process may explain the folds in clayey-gravelly sediments at the base of the Chochółów landslide. For the same reason the longitudinal section of this landslide shows marked loss of sediments in the clayey-gravelly part and a small one in the base clays ([Fig. 10](#)).
