Geohazard assessment of the coastal zone – the case of the southern Baltic Sea

Grzegorz UŚCINOWICZ¹, *, Tomasz SZARAFIN¹, Urszula PĄCZEK¹,
Miroslaw LIDZBARSKI¹ and Ewa TARNAWSKA¹

¹ Polish Geological Institute – National Research Institute, Marine Geology Branch, Kościarska 5, 80-328, Gdańsk, Poland

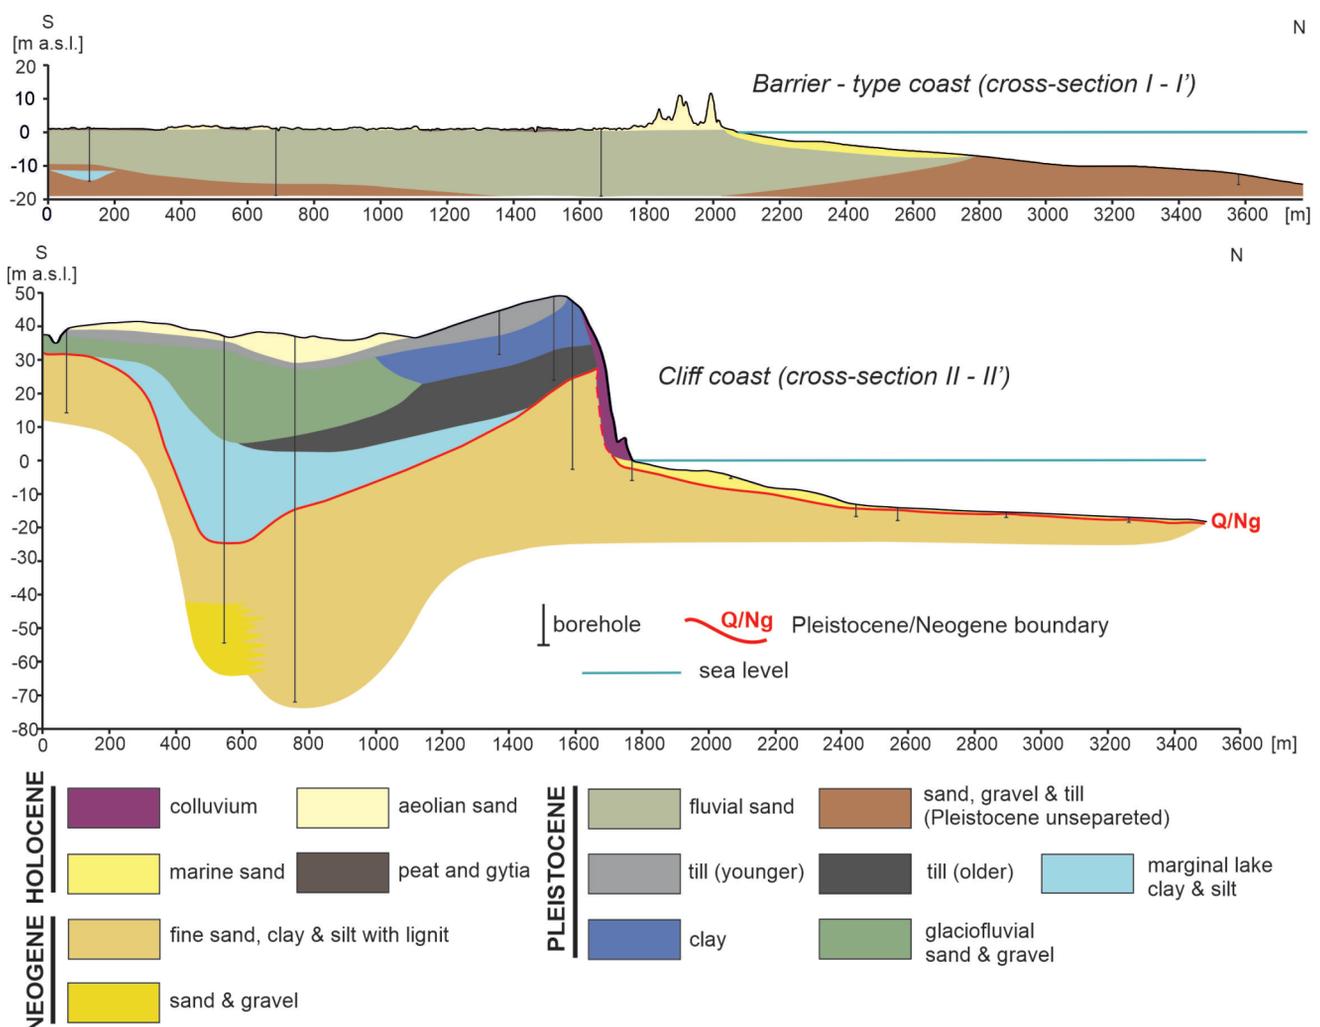
Fig. 2. Selected geological cross-sections illustrating the geological conditions of lowland (barrier – type coast) and upland (cliff coast) areas

The line of cross-section can be found on [Figure 1B](#) (Polish Geological Institute – National Research Institute materials)

The geological setting of this area is closely linked with its morphological structure. The low-lying area (the western and central parts of the study area) is built of fluvio-glacial sands overlain by Holocene lacustrine and biogenic deposits – fine sand, mud, gyttja and peat. The barrier is narrow, ranging from several tens of metres to 400 m across. It consists of fine and medium sand overlain by aeolian dunes, which are not higher than 20 m. Locally, peat is exposed on the beach or is present under a thin cover of beach sand. In general, the thickness of the marine sand barrier does not exceed 10 m. The eastern part is a morainic upland with its adjacent cliff. It is built of Miocene sand and silt with brown coal interbeds. Directly above lies fluvio-glacial sand and gravel, overlain in some places by a thin layer of till. Locally, on the surface of the upland, aeolian sheets with a thickness of up to 3 m occur. The geology of the lowland and the morainic upland have several published descriptions (Pawłowski, 1922; Rudowski, 1965; Uścińowicz et al., 2014, 2017; Moskalewicz et al., 2016; Uścińowicz and Szarafin, 2018; Widera, 2019) and may be illustrated by geological cross-sections (Fig. 2).

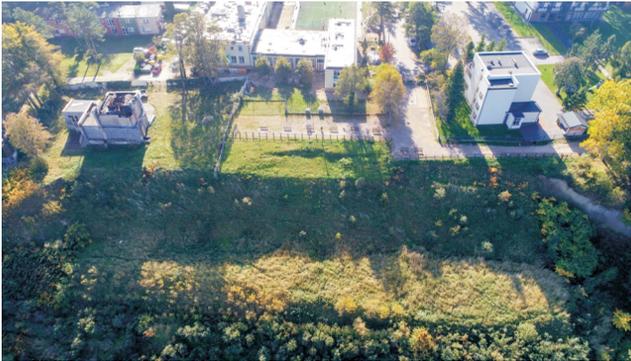
Fig. 3. Reclaimed and partly reactivated landslide at the Jastrzębia Góra resort (phot. M. Olkowicz)

The most active and devastating landslide, located in the western most part of the upland (134.25–134.50 km), has been reshaped and covered with a heavy hydrotechnical construction which is 235 m long and nearly 30 m high. The construction consists of four levels/steps secured on the outer side by blocks of rock which are enhanced with a steel mesh. In the adjacent landslide to the east, the slope has been reduced and the foot of the cliff is protected with a seawall (Fig. 3). Nevertheless, even

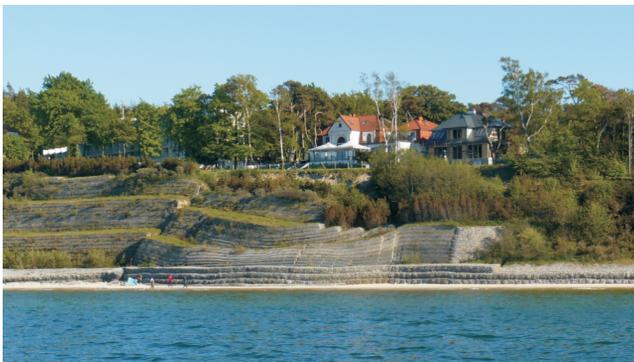
Fig. 4. Protective construction failure (phot. G. Uścińowicz)

these measures did not stop the mass movements, which subsequently became reactivated (Fig. 4).

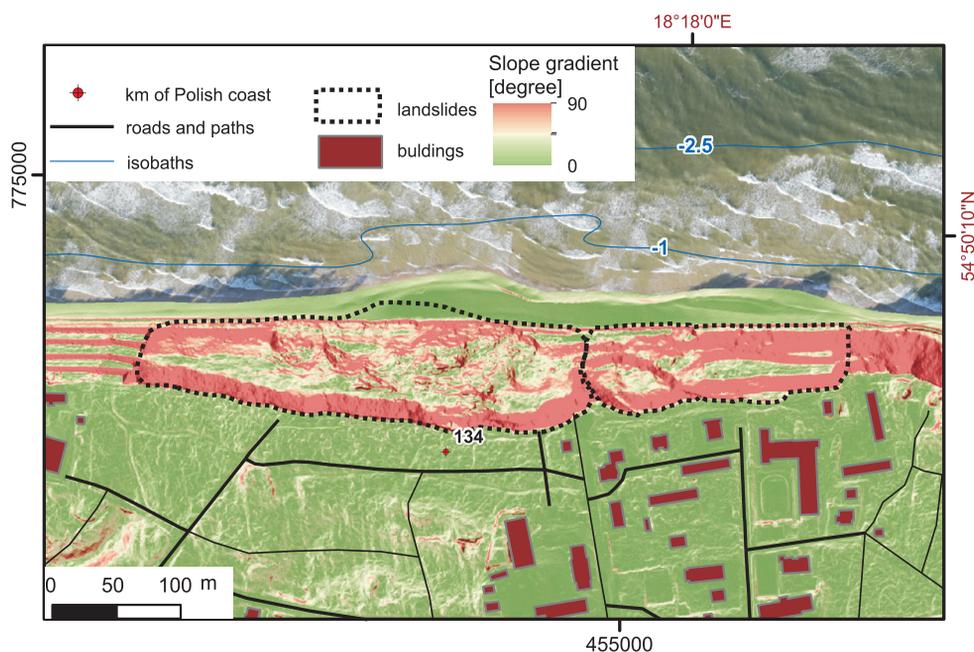
Fig. 5. Landslides on a slope map in the vicinity of threatened infrastructure

Landslides are located over 5.2 km of the 9 km coastal section, which corresponds to 69% of the upland's edge. Some of these, especially in the area of Jastrzębia Góra and Rozewie (between 130 and 135 km), directly threaten urban (Fig. 5) and navigation infrastructure.

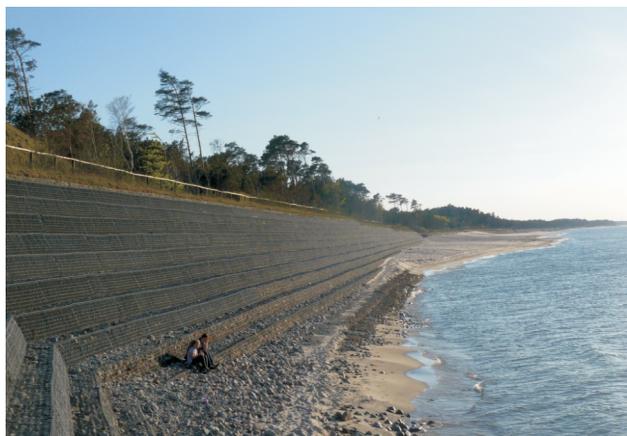
Fig. 8. Lack of beach in front of a seawall

Deficit zones are places of increased erosion of the seabed and the adjacent coast. A good example of this situation is the region of Jastrzębia Góra and Karwia, where both the cliff section (Fig. 7) and the barrier is eroded. The barrier type coast is much more vulnerable to marine erosion than are cliffs, which is why the observed shoreline retreat is much larger and better visible there. This, in turn, creates pressure to use further forms of coastal protection that raises new problems (Fig. 8).

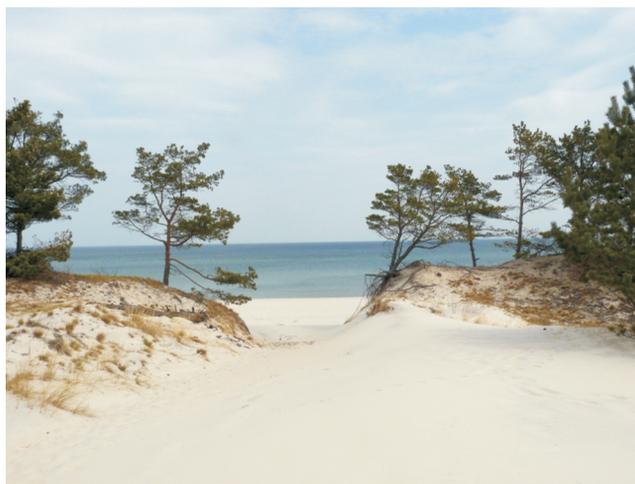
Fig. 9. Dune gap – a passageway for seawater

Photo taken on a barrier type coast (phot. G. Uścińowicz)

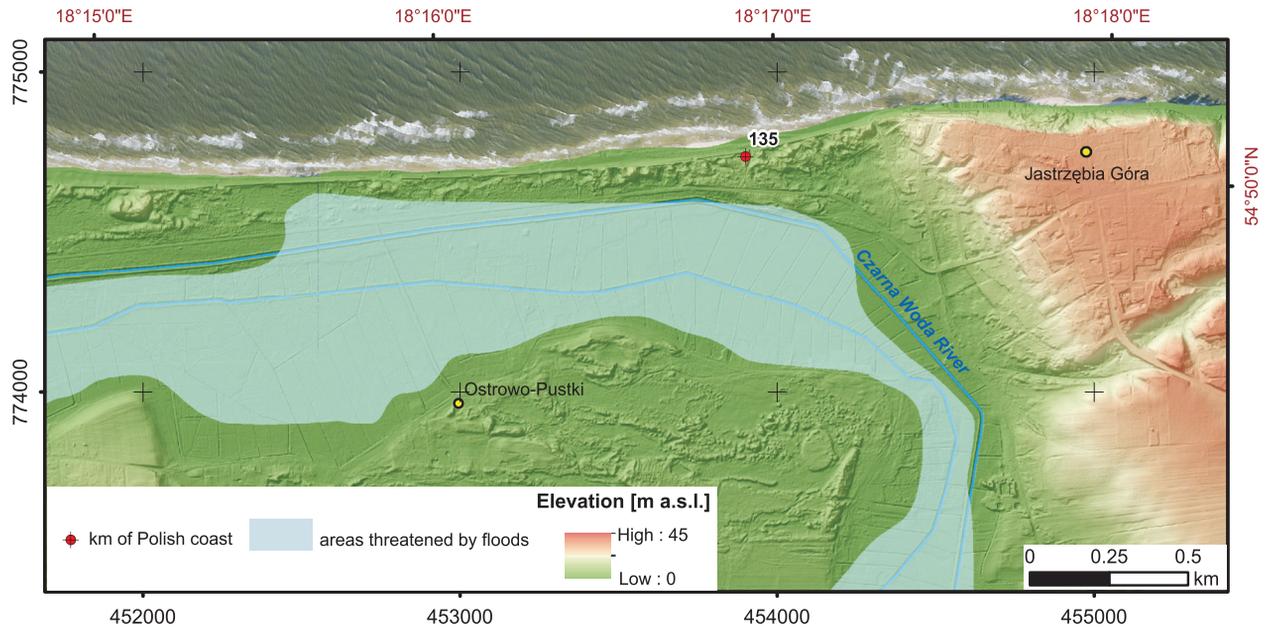
Fig. 10. Forecast of area threatened by floods as a result of groundwater level rise

Source of DTM – ISOK

Sea level rise can also particularly affect aquifers, especially their dynamics. A model assuming an increase of sea level of 1 m, as widely predicted, was adopted for simulation. Various scenarios have been made for the southern Baltic, projecting an increase in sea level by 2100 from ~0.5 m to >1 m (Meier et al., 2004; Staud et al., 2006). The worst-case scenario assuming an increase of 1 m has been adopted in this paper. This scenario, analysing the change in hydrodynamic conditions with drainage base levelled to 1 m a.s.l. showed far-reaching changes not only in groundwater dynamics, but also in the hydrographic system. Depending on the parameters of the aquifer system and its distance from the Baltic Sea, which is the main drainage base, the groundwater level will rise. As a consequence, significant floodplains are projected to occur in the river valleys and coastal low-lying areas, and some areas will be permanently flooded with groundwater (Fig. 10). Given these assumptions, an area of 27.4 km² may be flooded, which is 37% of the area investigated.

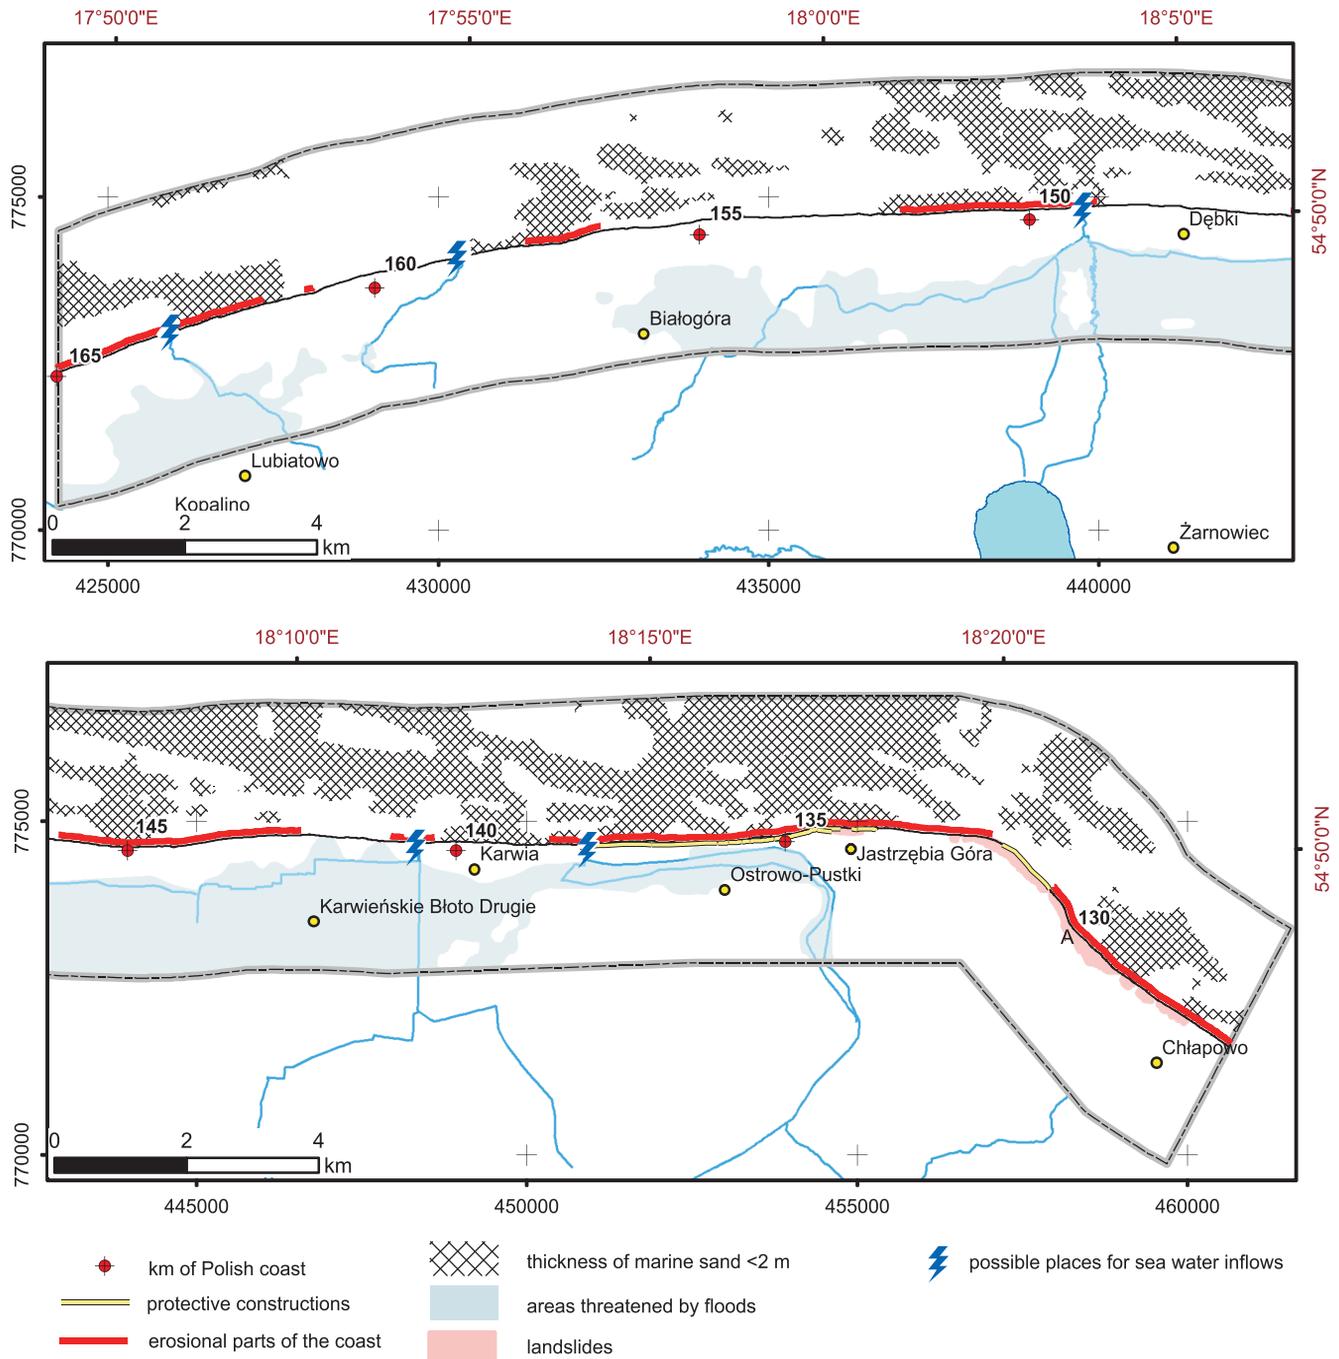
Fig. 11. Summary picture of the natural geological hazards identified

Summaries of these natural hazards are shown in Table 2 and Figure 11.
