The engineering geological and geotechnical conditions of Gediminas Hill (Vilnius, Lithuania): an update

We provide an update of engineering geological and geotechnical conditions at Gediminas Hill in Vilnius (Lithuania) from 1955 till 2020, which allows evaluation of the stability of its slopes. Active geological processes are still observed on Gediminas Hill. The latest landslides appeared on March 22, 2004 and on March 8, 2008 on the eastern slope above the hiking trail, as well on February 11, 2016 and February 13, 2016 on the northern part of the slope. The latest landslide (involving ~40 m³ of soil) took place on March 7, 2017 between the eastern and southern slopes. Eight hydrogeological units were distinguished in 2017. During 2019–2020 many engineering geological and geotechnical investigations have allowed determination of the possibilities and methods of slope stabilization.

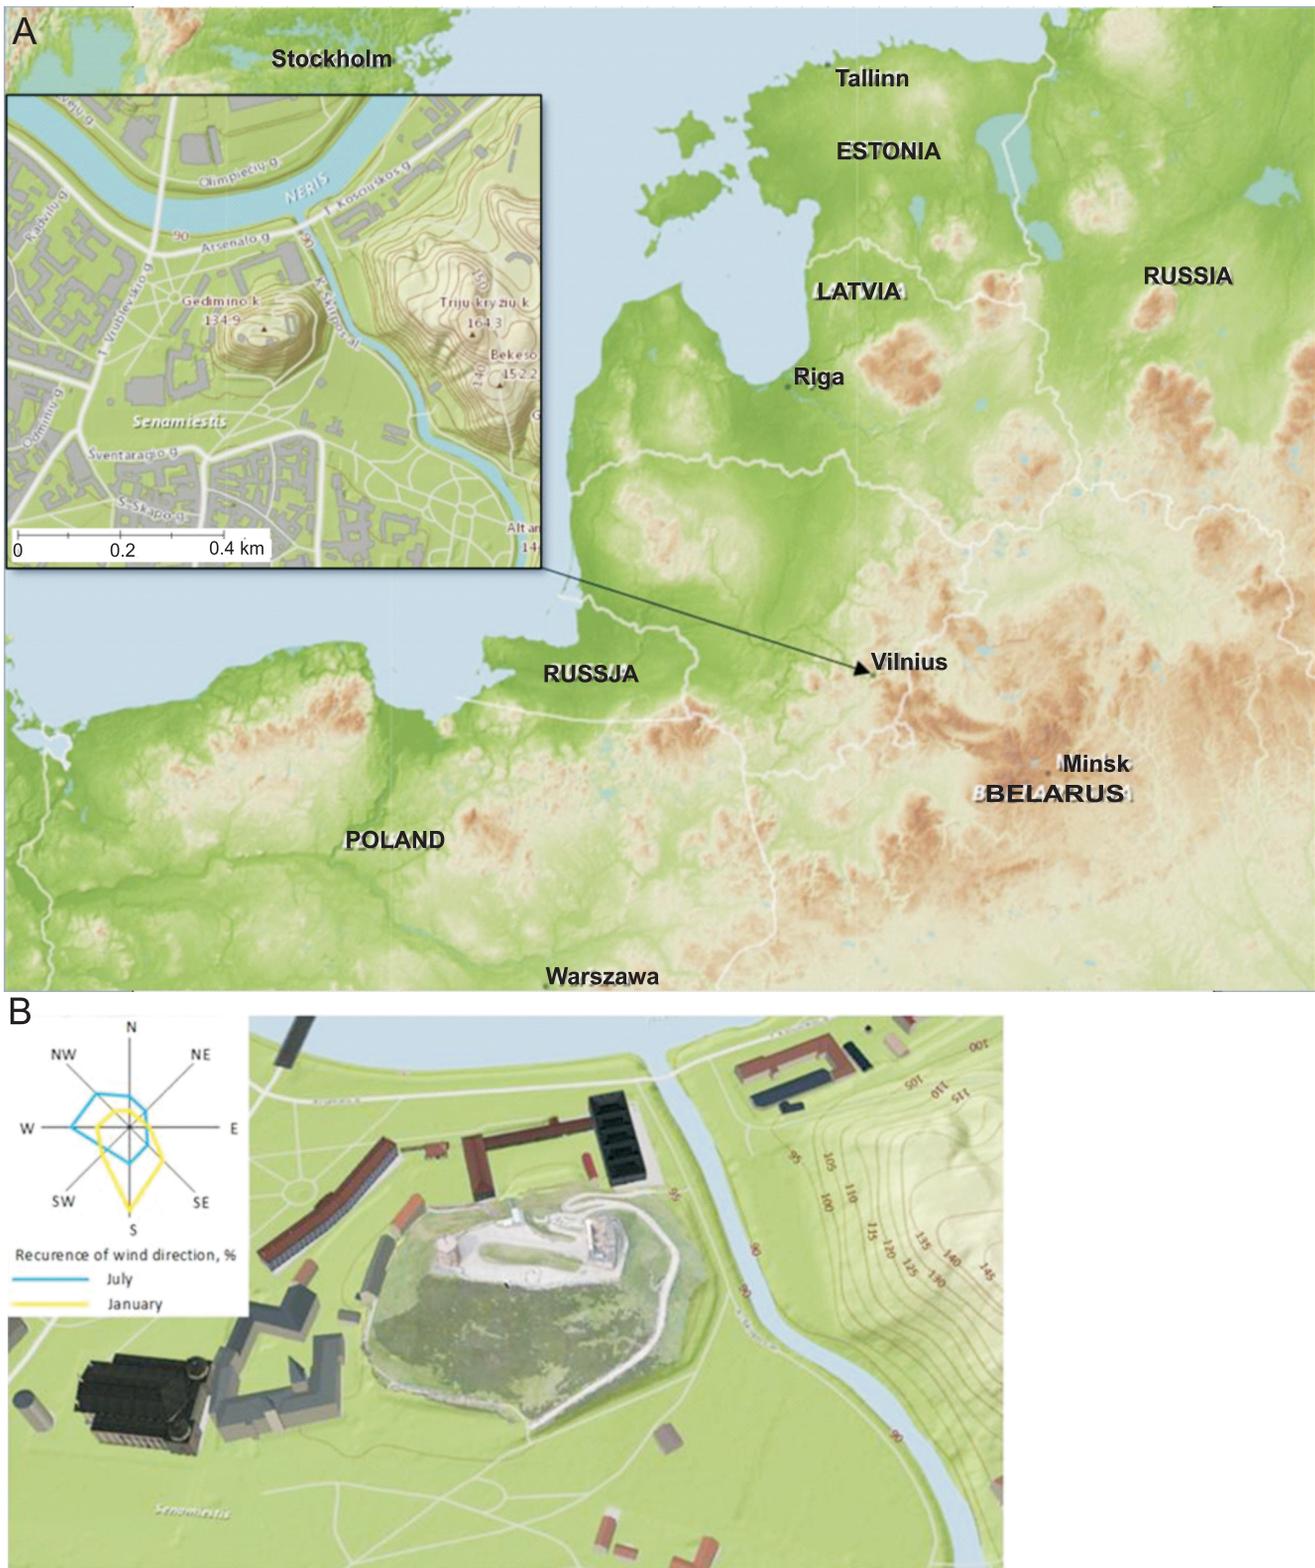
Fig. 1. Relief map: A – general map of investigation site location; B – Gediminas Hill 3D relief and wind directions

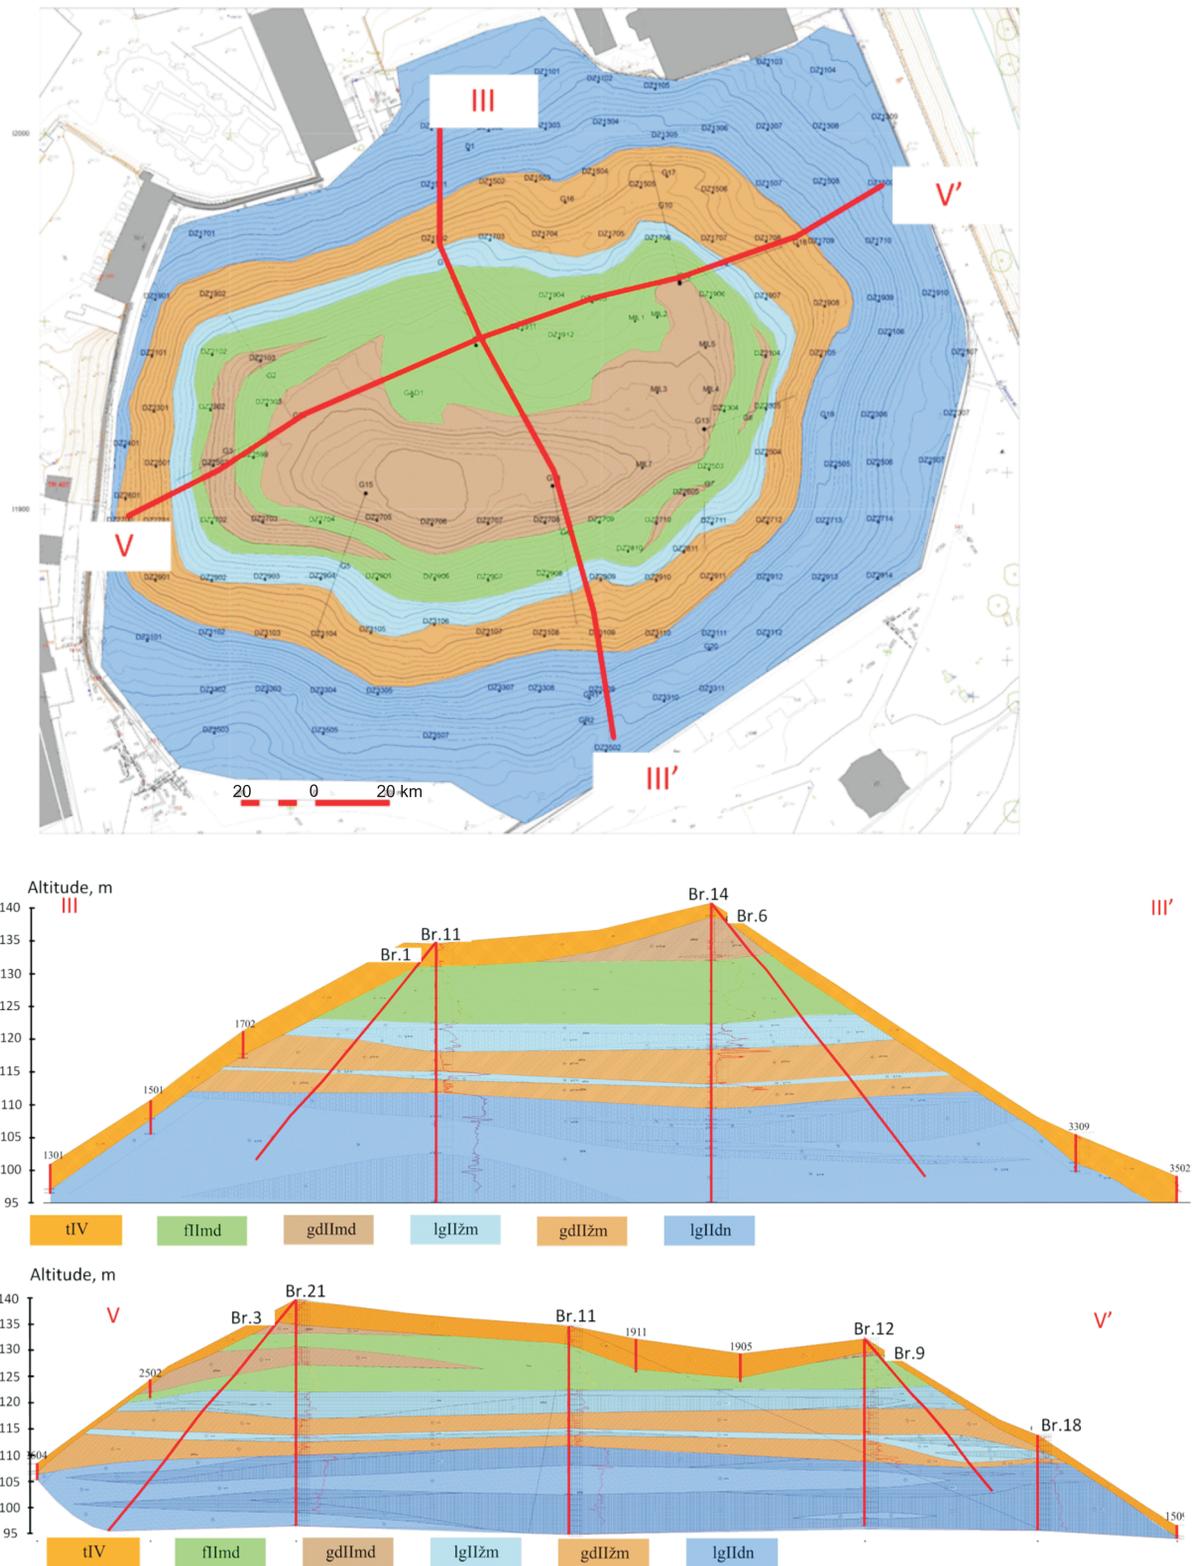
Fig. 2. Geological model of Gediminas Hill

tIV – Holocene technogenic soils; deposits of the Middle Pleistocene Medininkai (Warthian) Subformation: flIId – glaciofluvial; gdIId – glacial (deformational) till; deposits of the Middle Pleistocene Žemaitija (Saalian) Subformation: lgIIm – glaciolacustrine; gdIIm – glacial (deformational) till; lgIdn – glaciolacustrine deposits of the Middle Pleistocene Dainava (Elsterian 2) Formation. Red lines show lines of geological cross-section, while red vertical and diagonal lines on the geological cross-sections represent boreholes

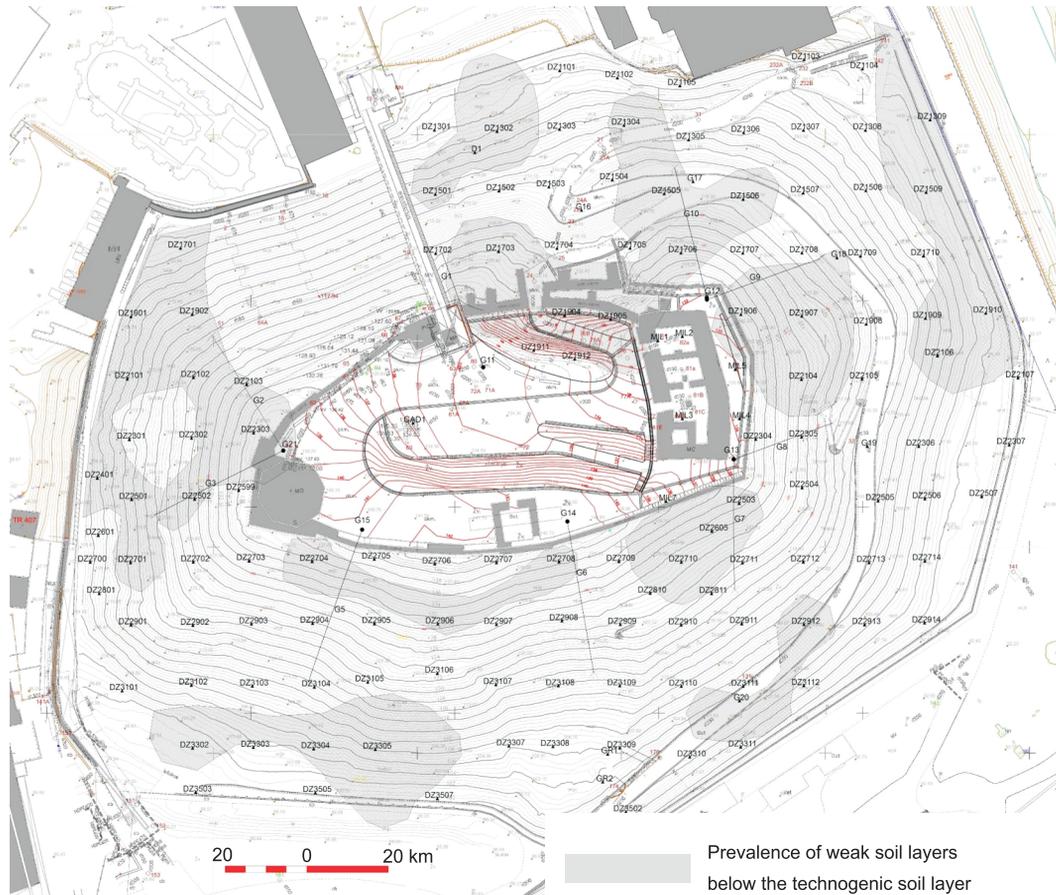
Fig. 3. Weak soil layers beneath the technogenic soil layer

The entire natural surface of Gediminas Hill is modified by human activity. The thickness of artificial deposits – technogenic soil (tlV) – varies from 2.4 to 4.6 m. They comprise humus-rich clayey sand and diamicton of various grades, as well as gravel, gravel and brick debris, pieces of carbonate cement, buried cultural layers, etc. The prevalence of weak soil layers exposed below technogenic structures is shown in [Figure 3](#), and a hydrogeological cross-section in [Figure 4](#).

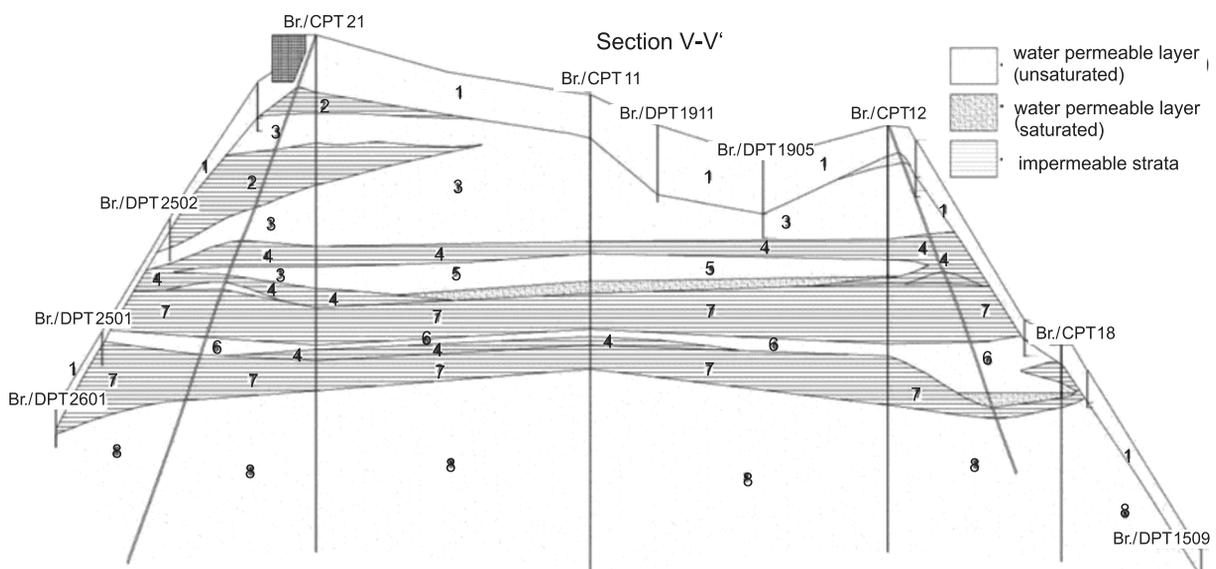
Fig. 4. Schematic hydrogeological cross-section V-V'

1 – tIV – permeable strata ($k = 0.4 \text{ m/d}$), 2 – gdlImd – impermeable strata, 3 – flImd – permeable strata ($k = 9 \text{ m/d}$), 4 – lglIžm – relatively impermeable strata, 5 – lglIžm permeable strata ($k = 0.3 \text{ m/d}$); 6 – lglIžm permeable intermoraine deposits ($k = 5.4 \text{ m/d}$), 7 – gdlIžm – impermeable strata, 8 – lglIdn – permeable strata ($k = 2.3 \text{ m/d}$)

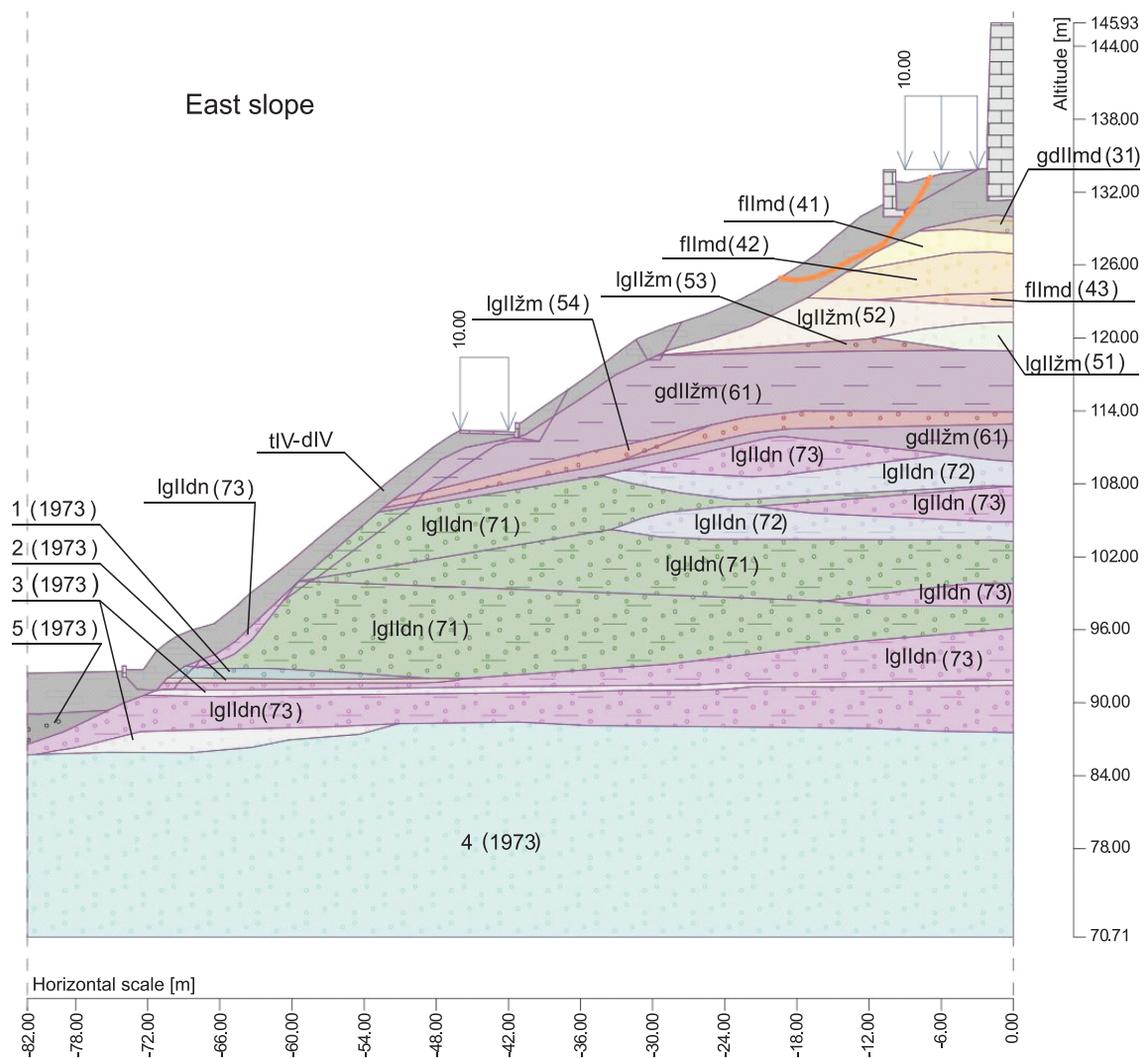
Fig. 6. Eastern slope stability analysis

In recent years, shallow landslides in the technogenic soil layer have appeared on the eastern slope in 2004 and recurred in 2008, and on the northern slope in 2016 (Skuodis and Ng, 2018). These landslides appeared due to extreme weather conditions with very large rainfall. The results shown in Figures 5–8 also show that the natural Gediminas Hill soil layers are stable enough. Also, since 2020, the Gediminas Hill top precipitation water collection and removal system has been completed. This partly helps to collect rainwater from the technogenic soil layer and avoids deeper soil saturation.

The utilization factors of slope stability were: in the northern part 82.5%, eastern part – 75.8%, southern part – 79.4%, western part – 71.9%. In the eastern part of Gediminas Hill the lowest slope stability utilization was found in the technogenic soil layer. This slope is mostly unstable and shows the largest probability of new shallow landslides if the technogenic soil layer becomes fully saturated. From the Gediminas Hill landslide history, the technogenic soil layer develops shallow landslides after severe precipitation with relatively high saturation levels.
