Recent sinkholes in an area of intensive karst development in northern Lithuania

Bucevičiūtė S. and Mikulėnas V. (2000) — Recent sinkholes in an area of intensive karst development in northern Lithuania. *Geol. Quart.*, 44 (4): 371–375. Warszawa.

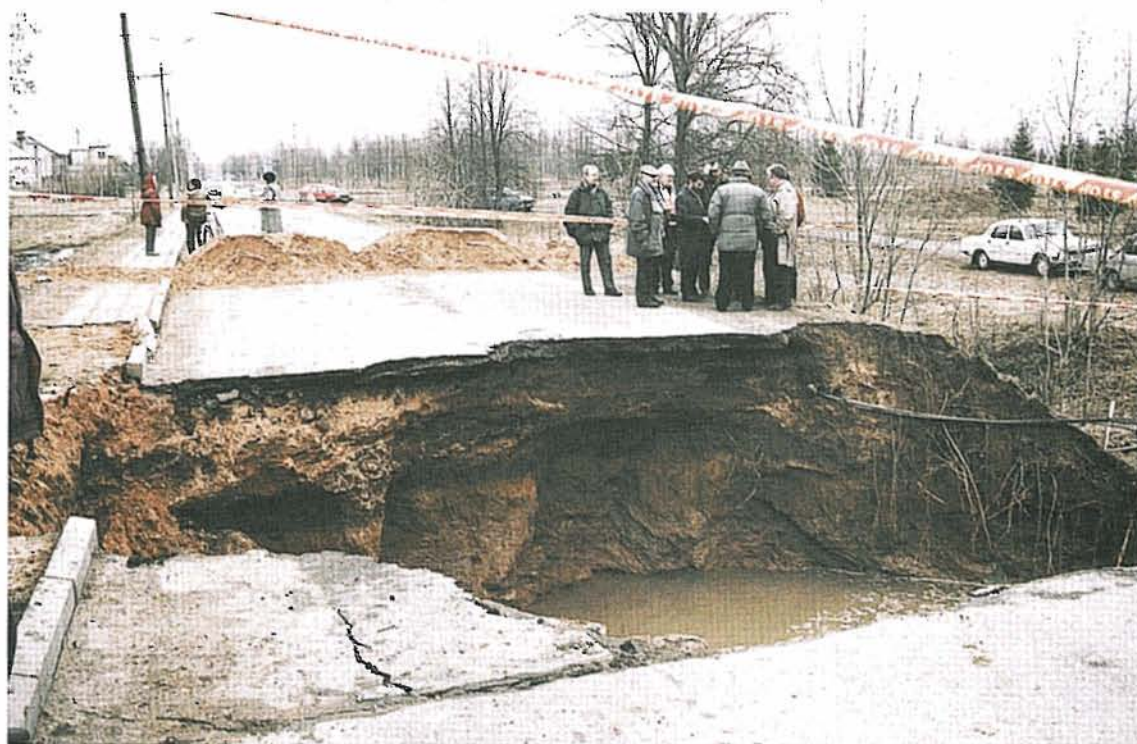
Fig. 2. The new sinkhole which suddenly opened on the Panevėžio Street, Pasvalys on March 5, 1997

The biggest sinkholes occurred in Pasvalys in 1995, 1997 and 1999 (Marcinkevičius and Taminskas in: *Geoindicators*, 1999). The first of them opened near the Vilnius Street in the centre of the town. It was 6 m wide and 21 m deep. The next sinkhole of 7–7.5 m wide and 7 m deep suddenly opened on Panevėžio Street in March 5, 1997 (Fig. 2). The third sinkhole, 15 m wide and 14 m deep, opened near Žalioji Street. The latter caused serious damage to two buildings (Fig. 3). The water-supply tower was tilted one side (deviation from the vertical axis reaching 55 cm) in Kirdonys, in the Biržai district. Waterlogged dolomitic sediment was found under the foundations, this possibly being the immediate cause of differential settlement (Fig. 4).

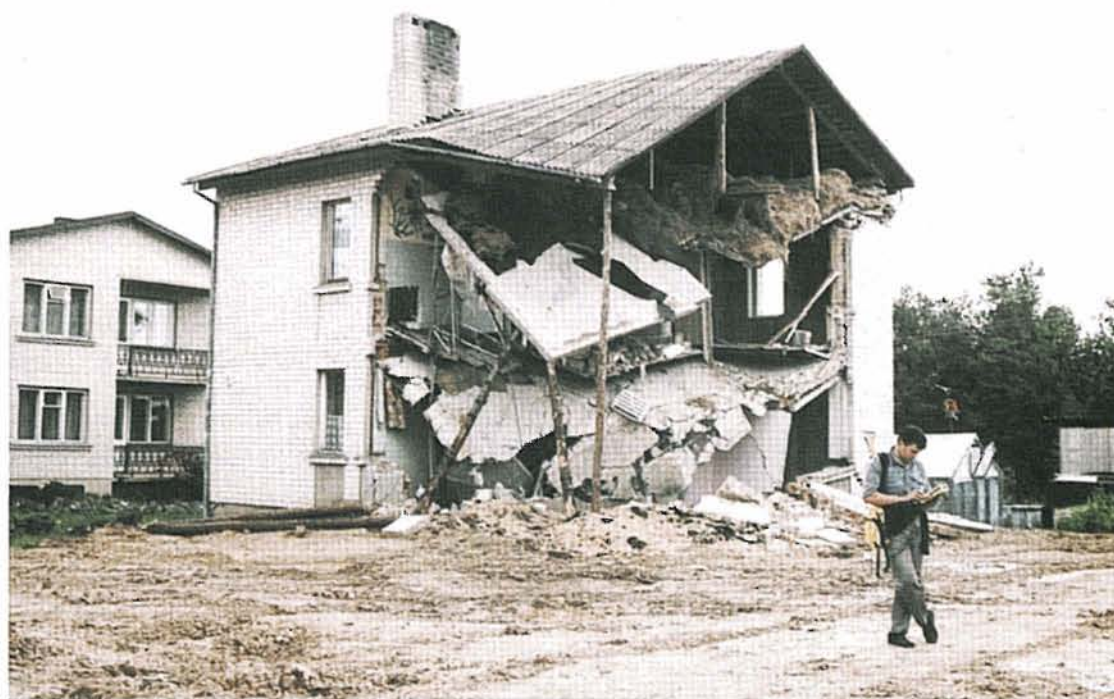
Fig. 3. Sinkhole appearance, with consequent damage to two buildings on June 15, 1999

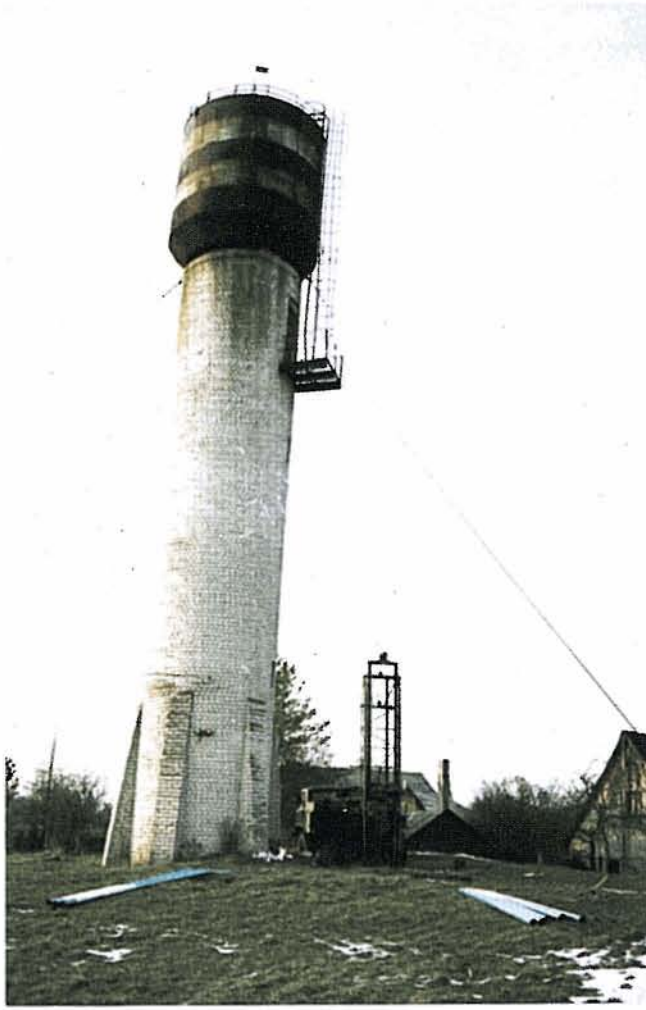
Fig. 4. The tilted water-supply tower in Kirdonys village, Biržai district

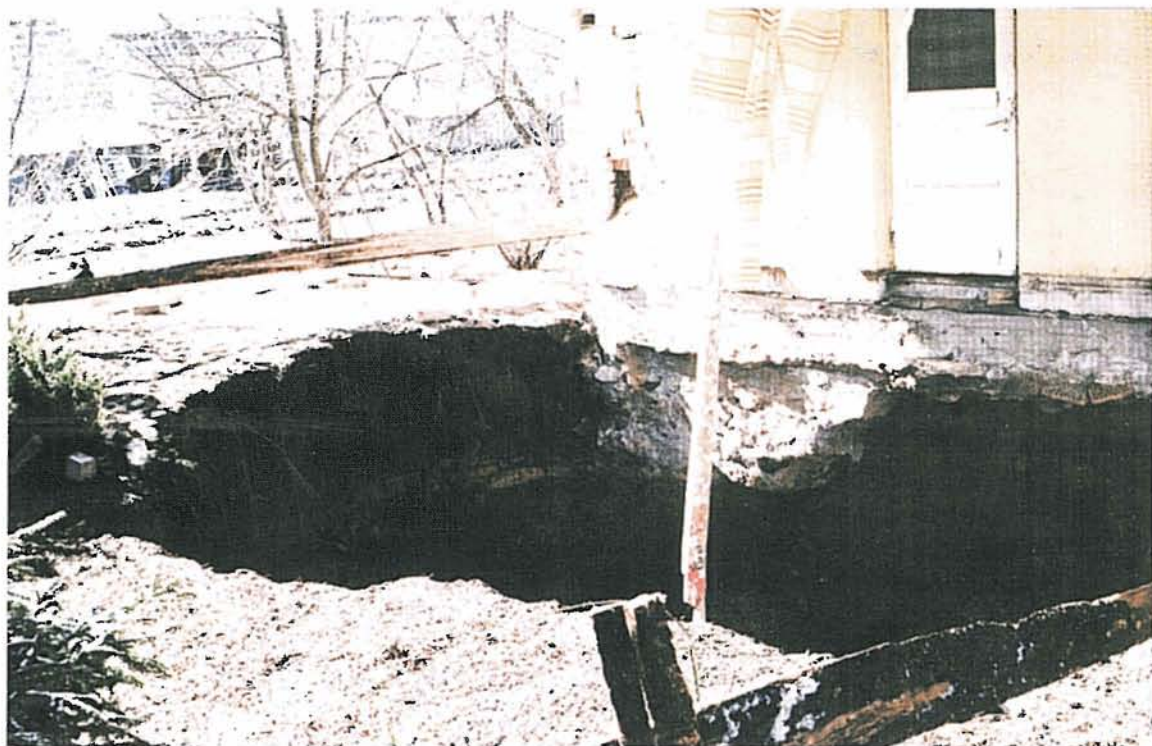
Fig. 5. Part of a house, after falling into a sinkhole 3–4 m wide and 5 m deep in Naciūnai village in April 11, 1997

These new sinkholes have produced a very sensitive engineering geological environment (Fig. 5). Data on the average number of sinkholes appearing every year are needed to assess the stability of the territory for construction and engineering. The sudden appearance of sinkholes and rapid ground subsidence may cause building failures requiring considerable finance for restoration work. The acceleration of karst processes in recent years may have been exacerbated by intensive economic activity (ground water exploitation, static and dynamic loading and so on).
